## Exterior + Roof Condition Report

Website sample property · capture 24 Sep 2026. Aerial documentation only — not a TREC home inspection, not an engineering report, not a leak test, not insurance.

### Overview — entire property condition

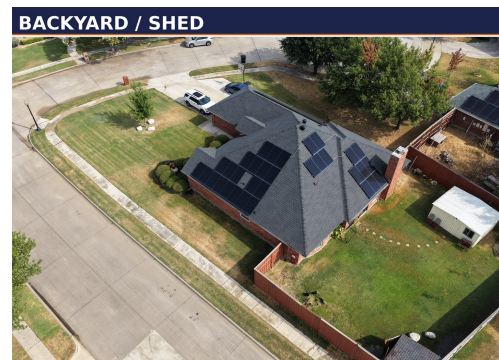
Backyard / shed

| Shed / outbuildings | 8.4 / 10 | Backyard shed upright and intact at overview altitude; no visible damage. |

| Shed | Intact | Overview altitude — shed upright and intact; no visible damage at this altitude. |

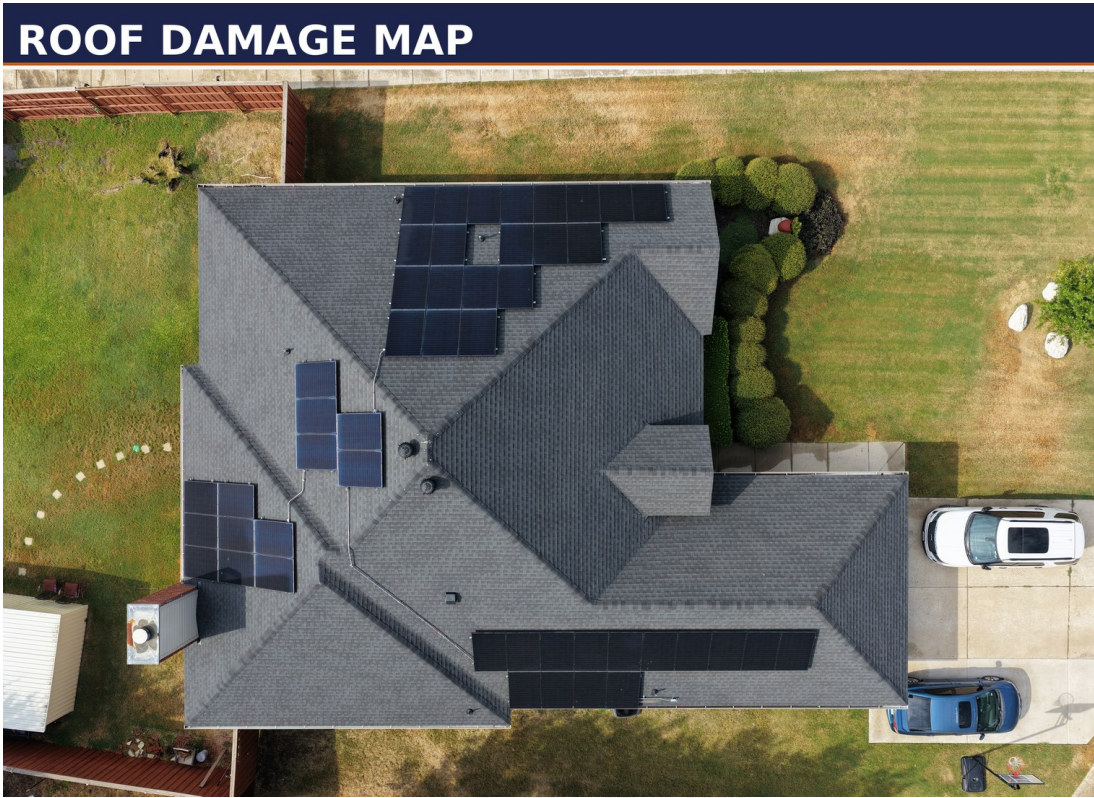
Roof overhead damage map

Circle positions are approximate, located from the closeup stills. Total circles drawn: 0 (none at medium/high confidence this pass).

Multi-facet residential roof with **architectural asphalt shingles** (gray/charcoal blend) and multiple rooftop solar arrays. Closeups across field, hip/ridge, solar edges, and soft-metal vents were reviewed. No repeating circular hail bruise field with black-mat exposure, no clear wind tear/lift/crease, and no clear circular soft-metal hail dent field met the medium/high pin threshold. Cosmetic vent scuffs and isolated ambiguous granule speckles were under-called to notes only. **Hail: not indicated. Wind: not indicated.** Documentation flight only — no storm date or claim causality stated.

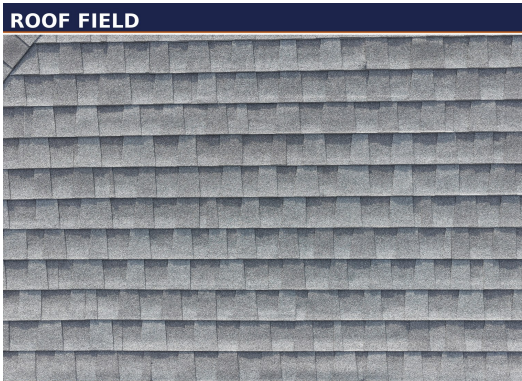
1 · Roof field

No medium/high-confidence defects were pinned on the reviewed closeups. Reference frames below document the covering and accessories as reviewed.

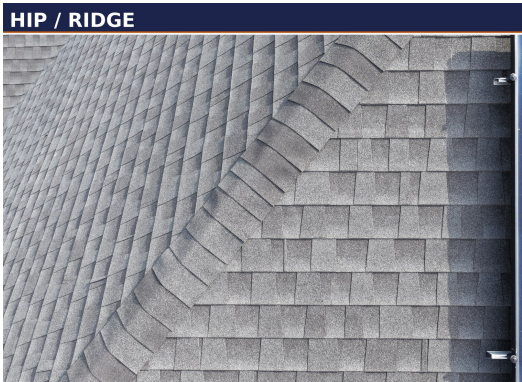
3 · Hip / ridge

| ● Wind | Not indicated | No missing tabs, clear crease folds, or displaced ridge/hip caps at medium/high confidence. |

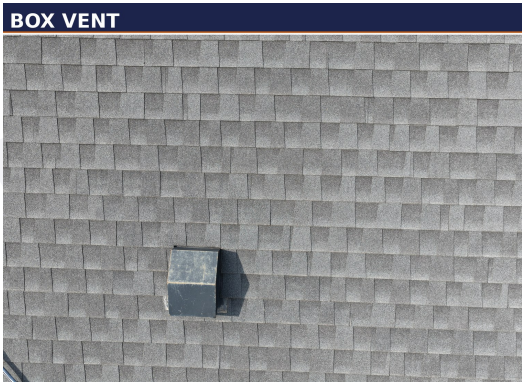
4 · Box vent

| Roof accessories / soft metal | 7.8 / 10 | Box vents present; cosmetic scuffs/oxidation only — no clear circular hail dent field at med/high confidence. |
