## Exterior + Roof Condition Report

Website sample property · capture November 2025. Aerial documentation only — not a TREC home inspection, not an engineering report, not a leak test, not insurance.

| Capture | November 2025 · overview + roof closeup stills | Pilot | Brady Pyle |

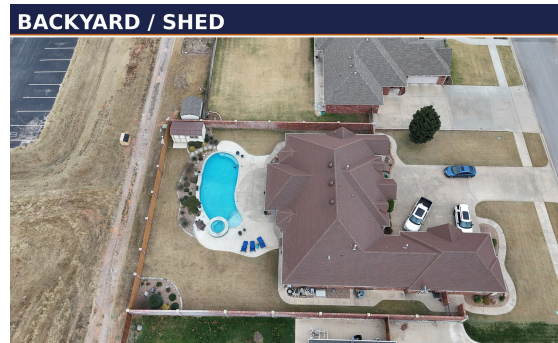
Backyard / shed

| Shed / outbuildings | 7.2 / 10 | Wood shed upright and intact at overview altitude; no visible damage. |

| Wood shed | Not assessed | Overview altitude only — wood shed upright and intact; too far away to assess for hail. |

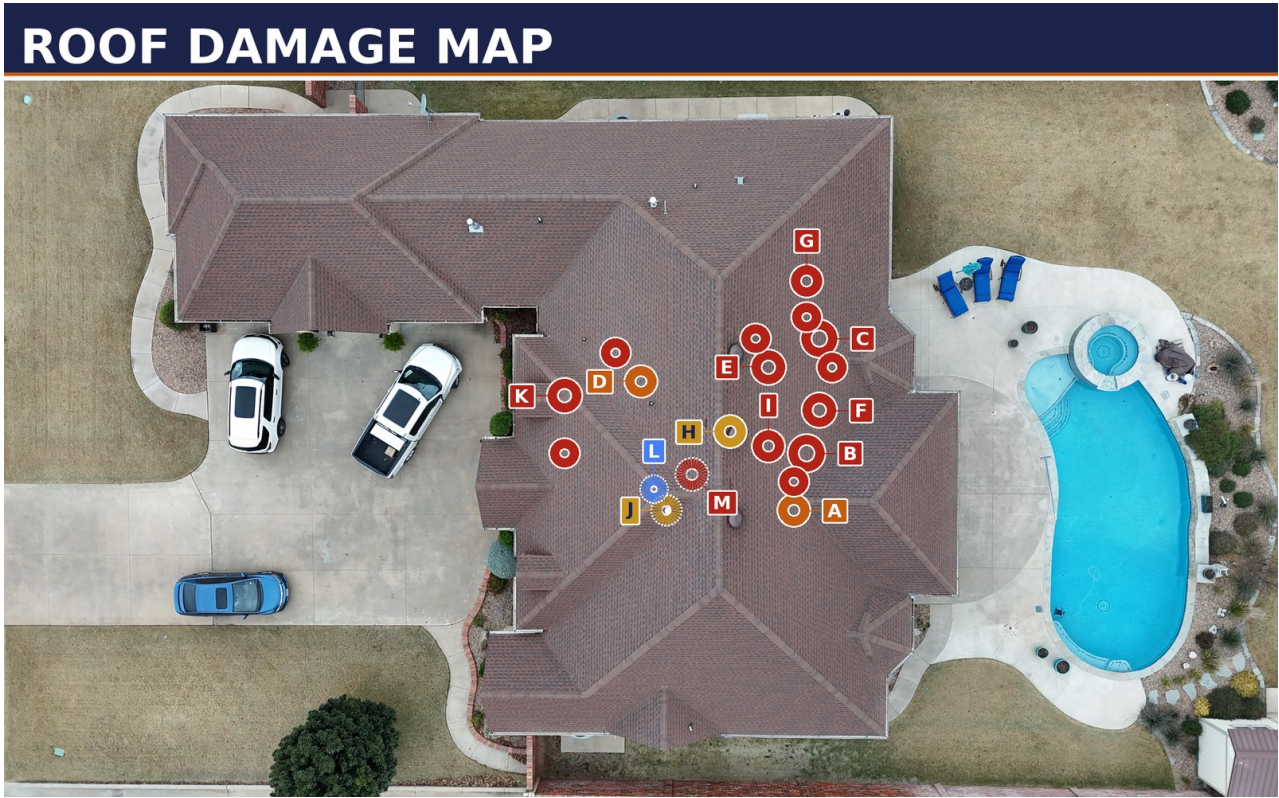
Circle positions are approximate, located from the closeup stills. Lettered pins A–M mark callout findings; unlabeled circles are additional distinct damage areas of the same types. Total circles drawn: 19.

Multi-facet residential roof with **architectural asphalt shingles** (weathered brown/tan blend). Closeups across pool-side, east, and west planes show **repeating circular hail impact bruises** with crushed granules and black-mat exposure — densest on the east slope (Pin C). **Wind** is indicated by a torn/cracked tab (Pin A) and a lifted/creased/folded tab at a hip–valley (Pin D). Soft-metal circular dents on the attic dome vent (Pin H) correlate with the covering bruise field but do not alone upgrade the call. Significant age-related granule thinning is visible and is reflected in the score and timeframe (age wear, not hail). **Hail: indicated. Wind: indicated.** Documentation flight only — no storm date or claim causality stated.

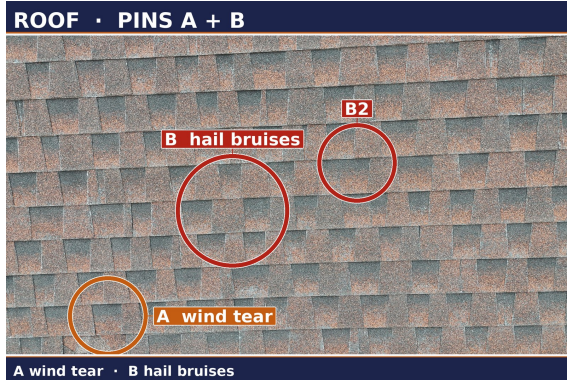
● 1 · Pins A + B

| Pin | Finding | Where | Class | Conf. | Notes / source still |
|---|---|---|---|---|---|
| ● A | Wind-torn / cracked shingle tab (triangular missing corner) | Pool-side field, bottom course | Wind (hard) | High | Jagged triangular tear exposing underlayer; mechanical wind/uplift failure. Frames: 0010. |
| ● B | Hail impact bruises — circular black-mat exposures (bruise field) | Pool-side field | Hail (hard) | High | Repeating circular/near-circular granule bruises with black-mat exposure across adjacent courses. Frames: 0010, 0011. |

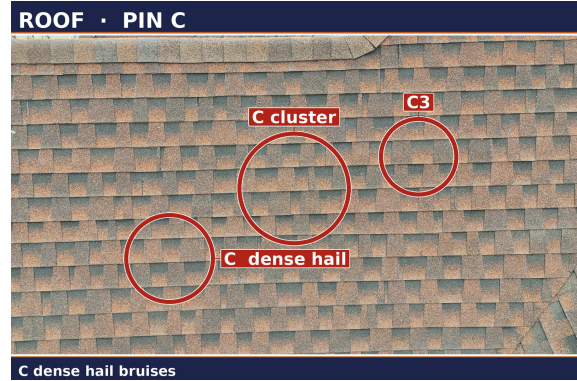
● 2 · Pin C

| Pin | Finding | Where | Class | Conf. | Notes / source still |
|---|---|---|---|---|---|
| ● C | Dense hail impact bruise field (high count) | East / driveway-side slope | Hail (hard) | High | Highest density of distinct circular black-mat bruises in the close-up set (~dozen+ in frame). Frames: 0016, 0017. |

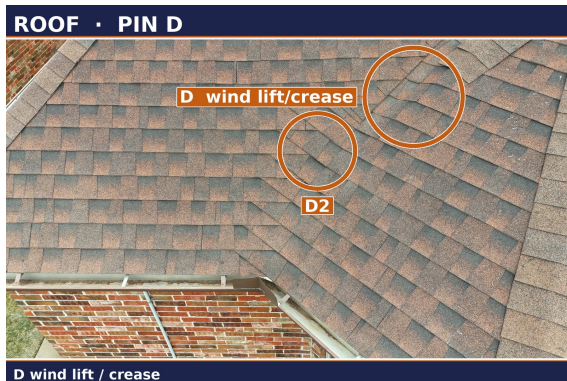
● 3 · Pin D

| Pin | Finding | Where | Class | Conf. | Notes / source still |
|---|---|---|---|---|---|
| ● D | Wind-lifted / creased / folded shingle tab(s) at hip-valley | Hip / valley intersection | Wind (hard) | High | Tab folded/lifted with sharp crease; classic wind uplift signature. Frames: 0022. |

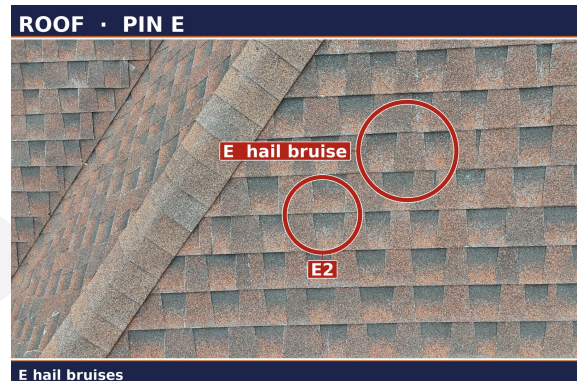
● 4 · Pin E

| Pin | Finding | Where | Class | Conf. | Notes / source still |
|---|---|---|---|---|---|
| ● E | Hail impact bruises on hip-adjacent field | Pool-side hip / field plane | Hail (hard) | High | Multiple circular bruise marks on field tabs and hip-adjacent courses. Frames: 0012, 0013. |

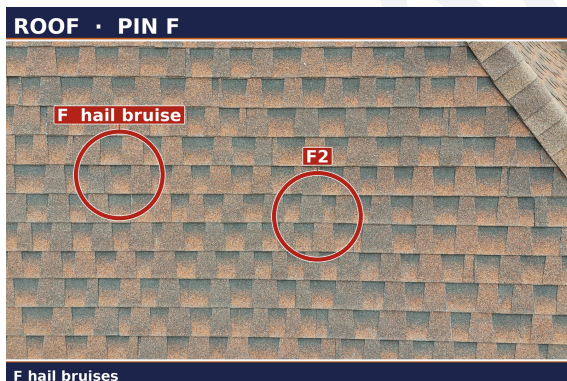
● 5 · Pin F

| Pin | Finding | Where | Class | Conf. | Notes / source still |
|---|---|---|---|---|---|
| ● F | Hail impact bruises — continuing east mid-field | East slope mid-field | Hail (hard) | High | Repeating circular bruise pattern matching Pin C; not isolated lookalikes. Frames: 0018, 0019. |

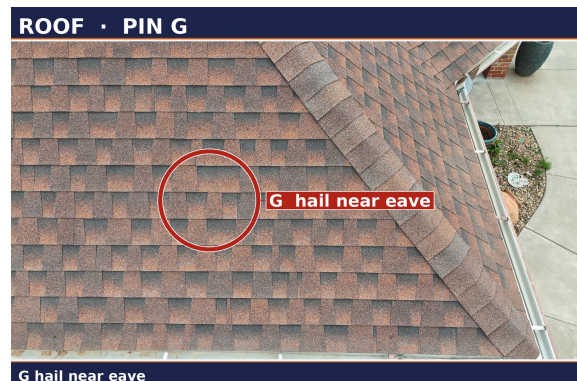
● 6 · Pin G

| ● G | Hail impact bruises near northeast eave / hip termination | Northeast eave / hip | Hail (hard) | Med–High | Circular bruises in field near eave on the covering. Frames: 0020. |

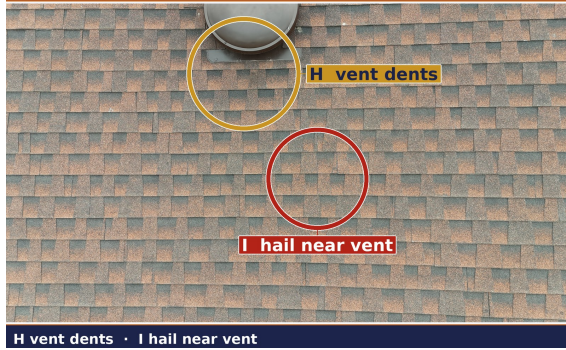
● ● 7 · Pins H + I

H vent dents · I hail near vent

| ■ H | Soft-metal hail impact dents on attic dome (turtle) vent | Upper slope dome vent | Soft metal / hail correlation (hard) | High | Shallow circular indentations on bronze/brown dome top; supports covering bruise field (not alone). Frames: 0026, 0027. |
| ● I | Hail impact bruises on field surrounding dome vent | Field adjacent to attic vent | Hail (hard) | High | Circular black-mat bruises on tabs near vent; correlates with Pin H soft-metal dents. Frames: 0026, 0027. |

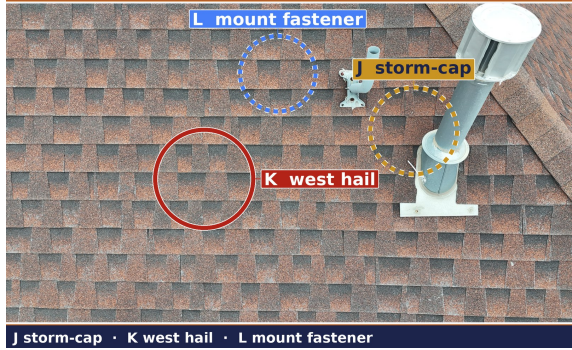
● ● ● 8 · Pins J + K + L

J storm-cap · K west hail · L mount fastener

| ■ J | Possible soft-metal impact marks on plumbing vent storm cap | West slope plumbing stack | Soft metal / hail correlation (soft) | Med | Faint circular indentations on storm-cap top at available zoom; soft-call. Frames: 0030. |
| ● L | Missing fastener + rusted fasteners at equipment mount | West slope satellite/equipment bracket near plumbing vent | Accessory / fastening (soft) | Med–High | One empty mount hole; remaining fasteners show rust bleed; heavy sealant at base. Frames: 0030. |

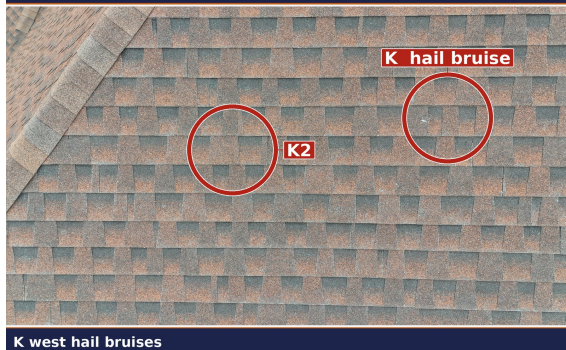
● 9 · Pin K

K west hail bruises

| ● K | Hail impact bruises — west slope field | West / street-side planes | Hail (hard) | High | Continuing circular bruise pattern across west close-ups; multi-facet, not one-slope only. Frames: 0029, 0030, 0031, 0033. |

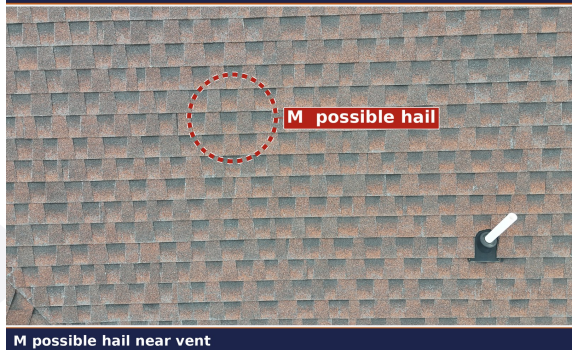
● 10 · Pin M

M possible hail near vent

| ● M | Possible hail impact bruises near plumbing vent area | West-of-pool field near pipe vent | Hail (soft) | Med | Scattered circular dark marks consistent with bruises; zoom imperfect on some pits. Frames: 0014. |
