## Exterior + Roof Condition Report

Website sample property · capture November 2025. Aerial documentation only — not a TREC home inspection, not an engineering report, not a leak test, not insurance.

| Capture | November 2025 · overview + roof closeup stills | Pilot | Brady Pyle |

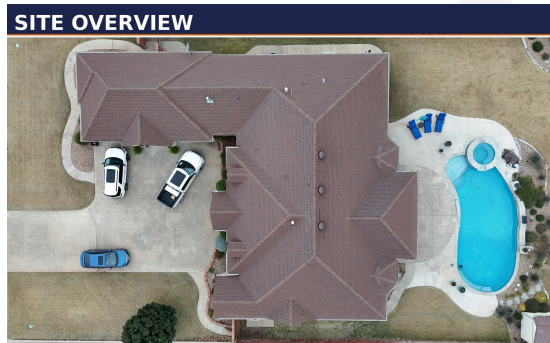
Whole-property overview

| <b>5.8 / 10</b><br><br>Visual score 0–10 | Brick residence with multi-facet <b>architectural asphalt shingles</b> , pool yard, and wood shed. Roof closeups show <b>repeating circular hail impact bruises</b> (black-mat exposure) across multiple slopes, plus <b>wind</b> damage (torn tab; lifted/creased tab at hip–valley). Soft-metal circular dents on the attic dome vent correlate with the covering bruise field. Wood shed reviewed at overview altitude — upright and intact, no visible damage. <b>Hail: indicated. Wind: indicated.</b> | <b>Overall visual property score</b> |

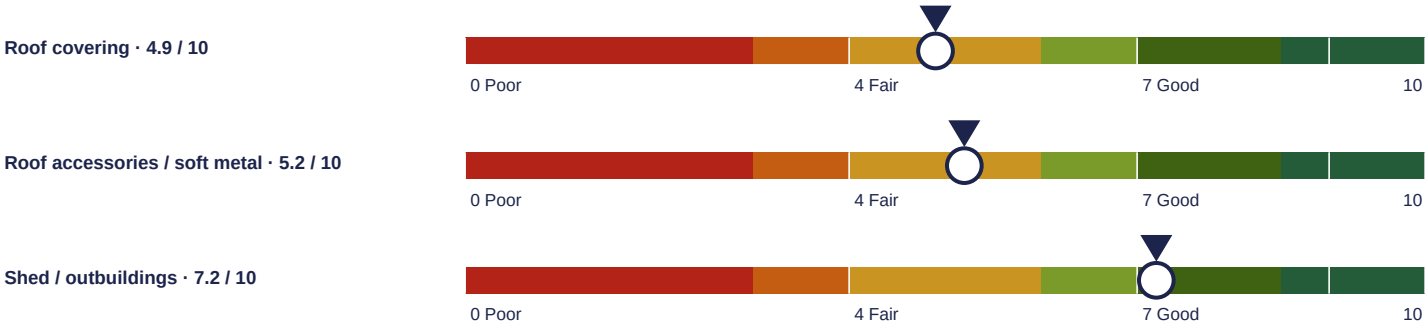
Component ScoreBars

| Roof covering | 4.9 / 10 | Hail bruise fields on multiple slopes; wind tear + wind-lifted/creased tab; mid–late granule wear noted in summary. |
| Roof accessories / soft metal | 5.2 / 10 | Circular hail dents on attic dome vent; possible storm-cap marks; missing/rusted mount fastener. |
| Shed / outbuildings | 7.2 / 10 | Wood shed upright and intact at overview altitude; no visible damage. |
